Town of Cardston Infrastructure Master Plan

Report

Update: December, 2017

**RE: TOWN OF CARDSTON
INFRASTRUCTURE MASTER PLAN**

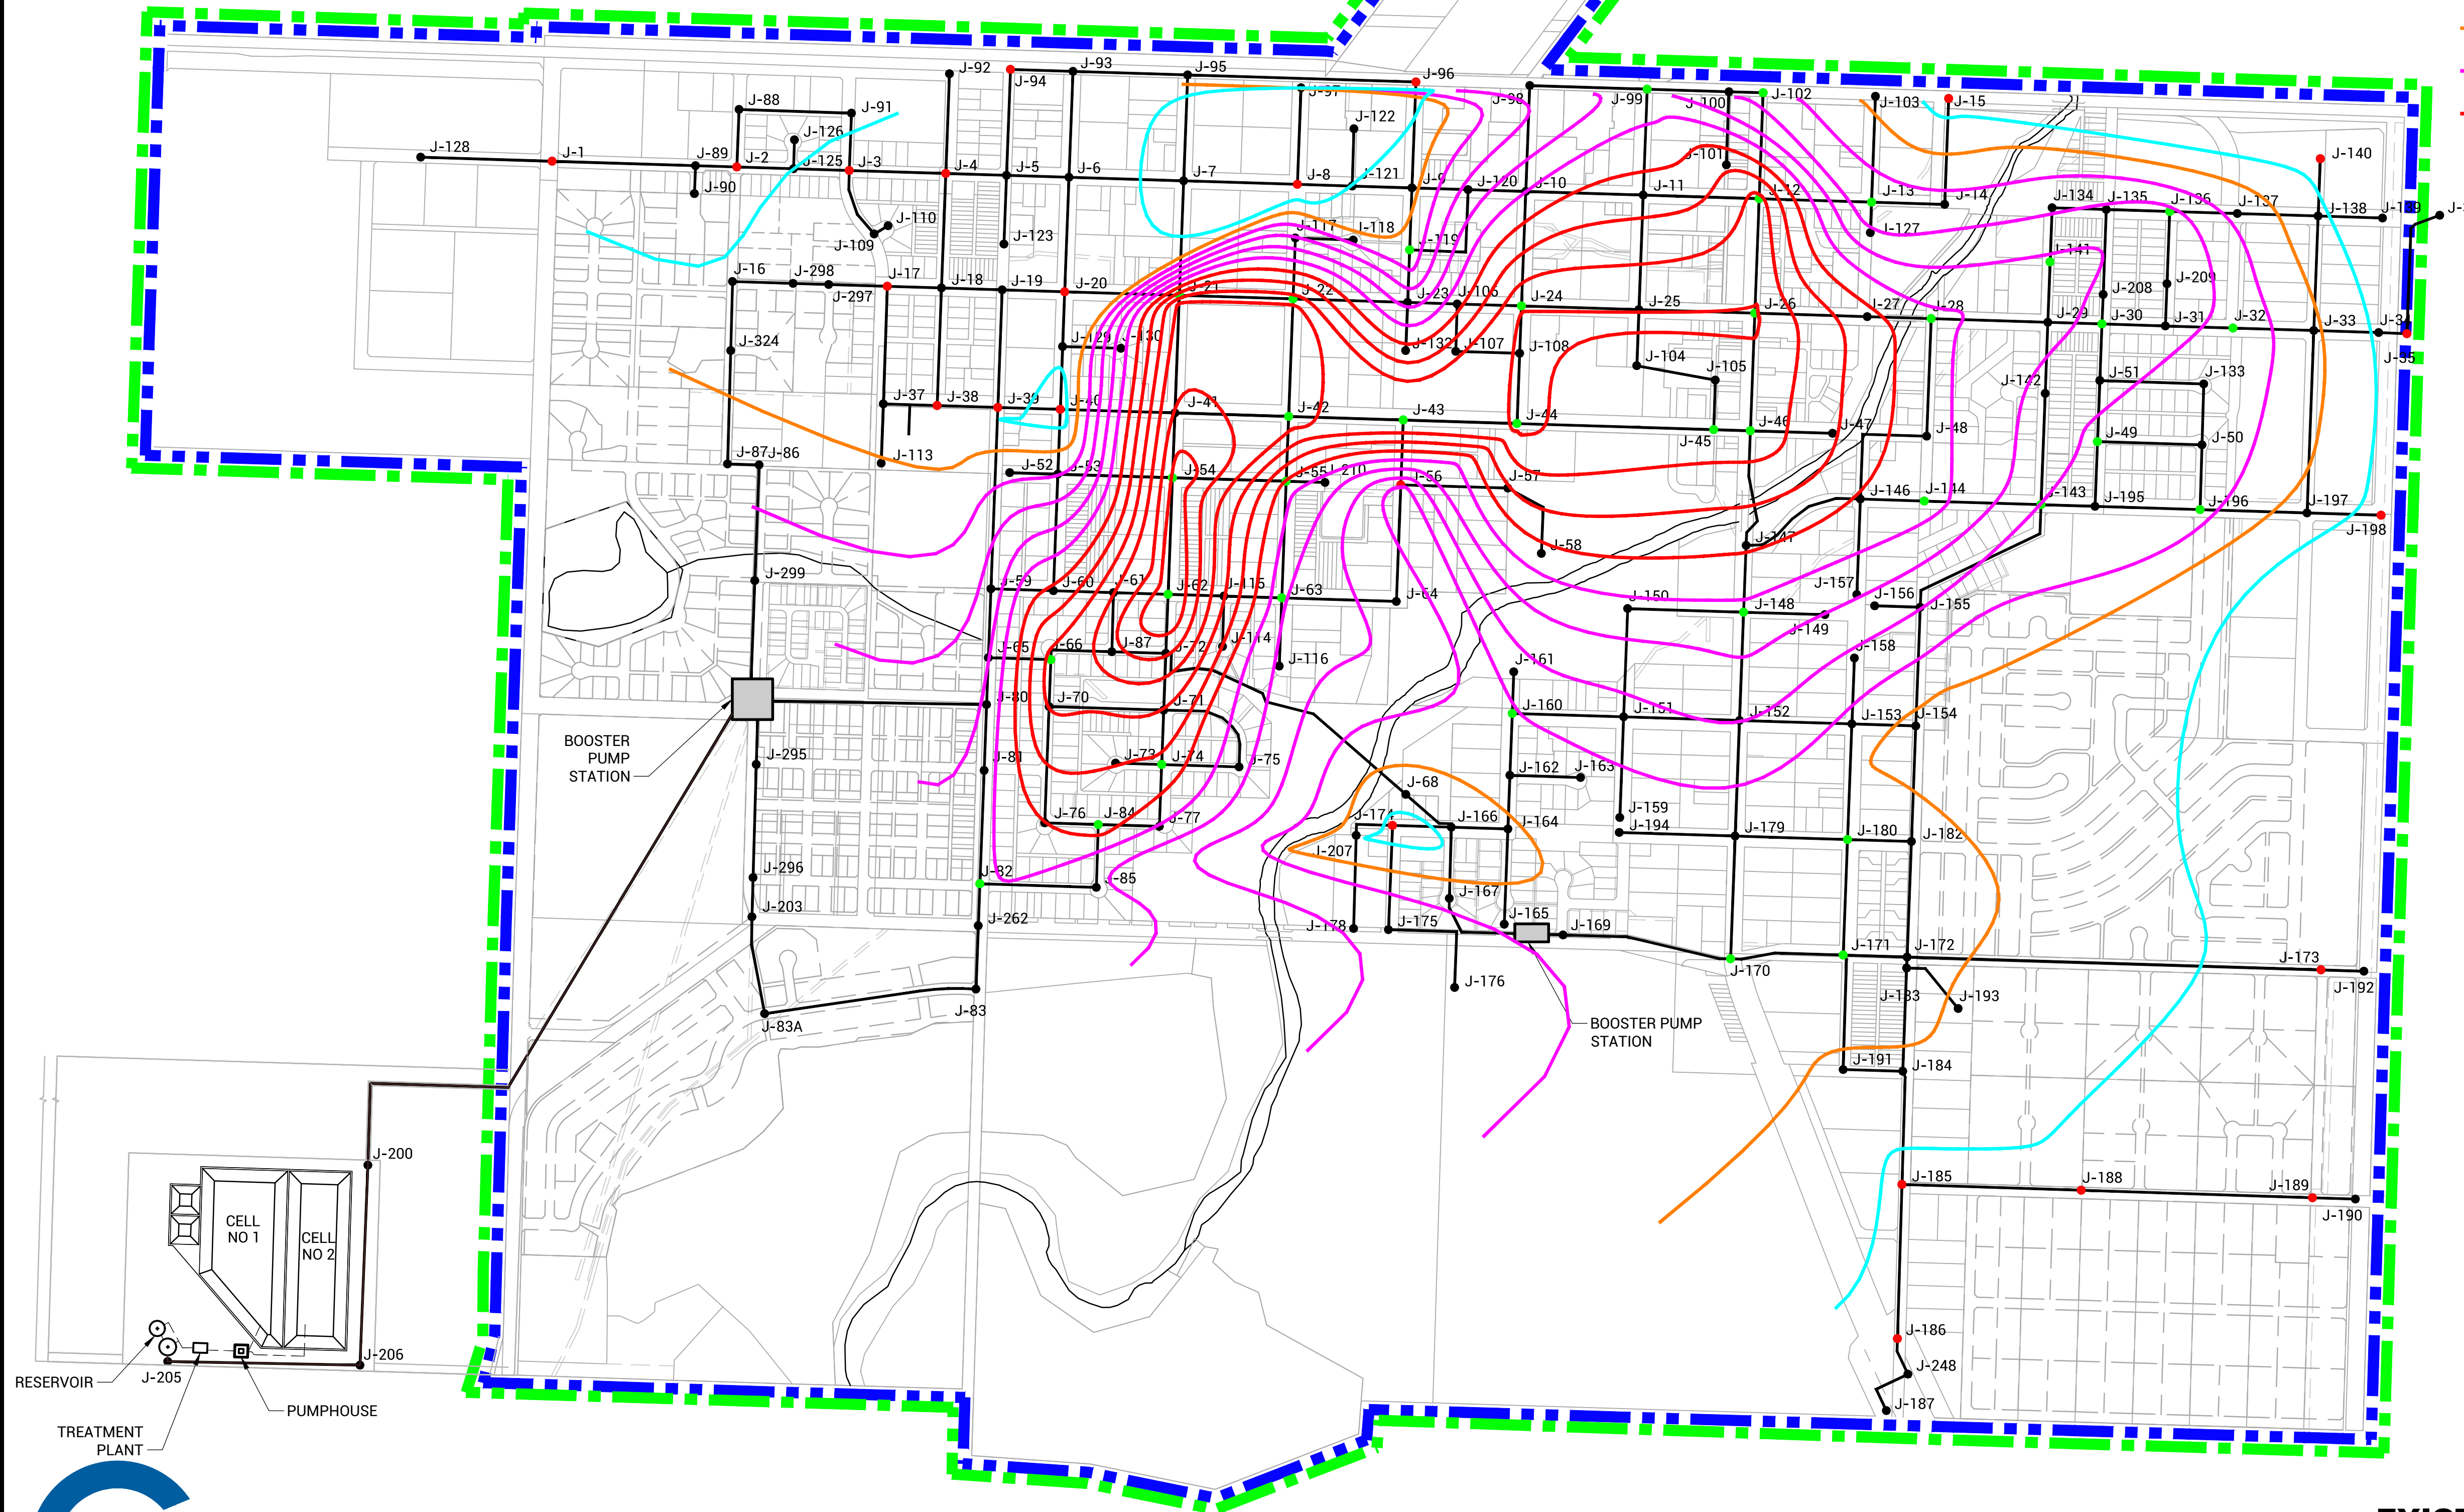
**EXISTING WATER DISTRIBUTION SYSTEM
MAXIMUM DAY PLUS FIRE FLOW - 85 PSI
FIGURE 3.4**

The available fire flows in the Town of Cardston range from 40 to 250 L/s. As shown on **Figure 3.4**, most of the residential areas at the center of the Town have adequate fire flows. These areas are mostly gravity fed and would require further improvements to increase fire flows to some neighboring hydrants.

For the existing system, the main upgrades were considered only for main lines in the water distribution system where upgrades would be the most cost effective and provide the greatest benefit. The upgrades required to improve local deficiencies should be considered as secondary upgrades, and

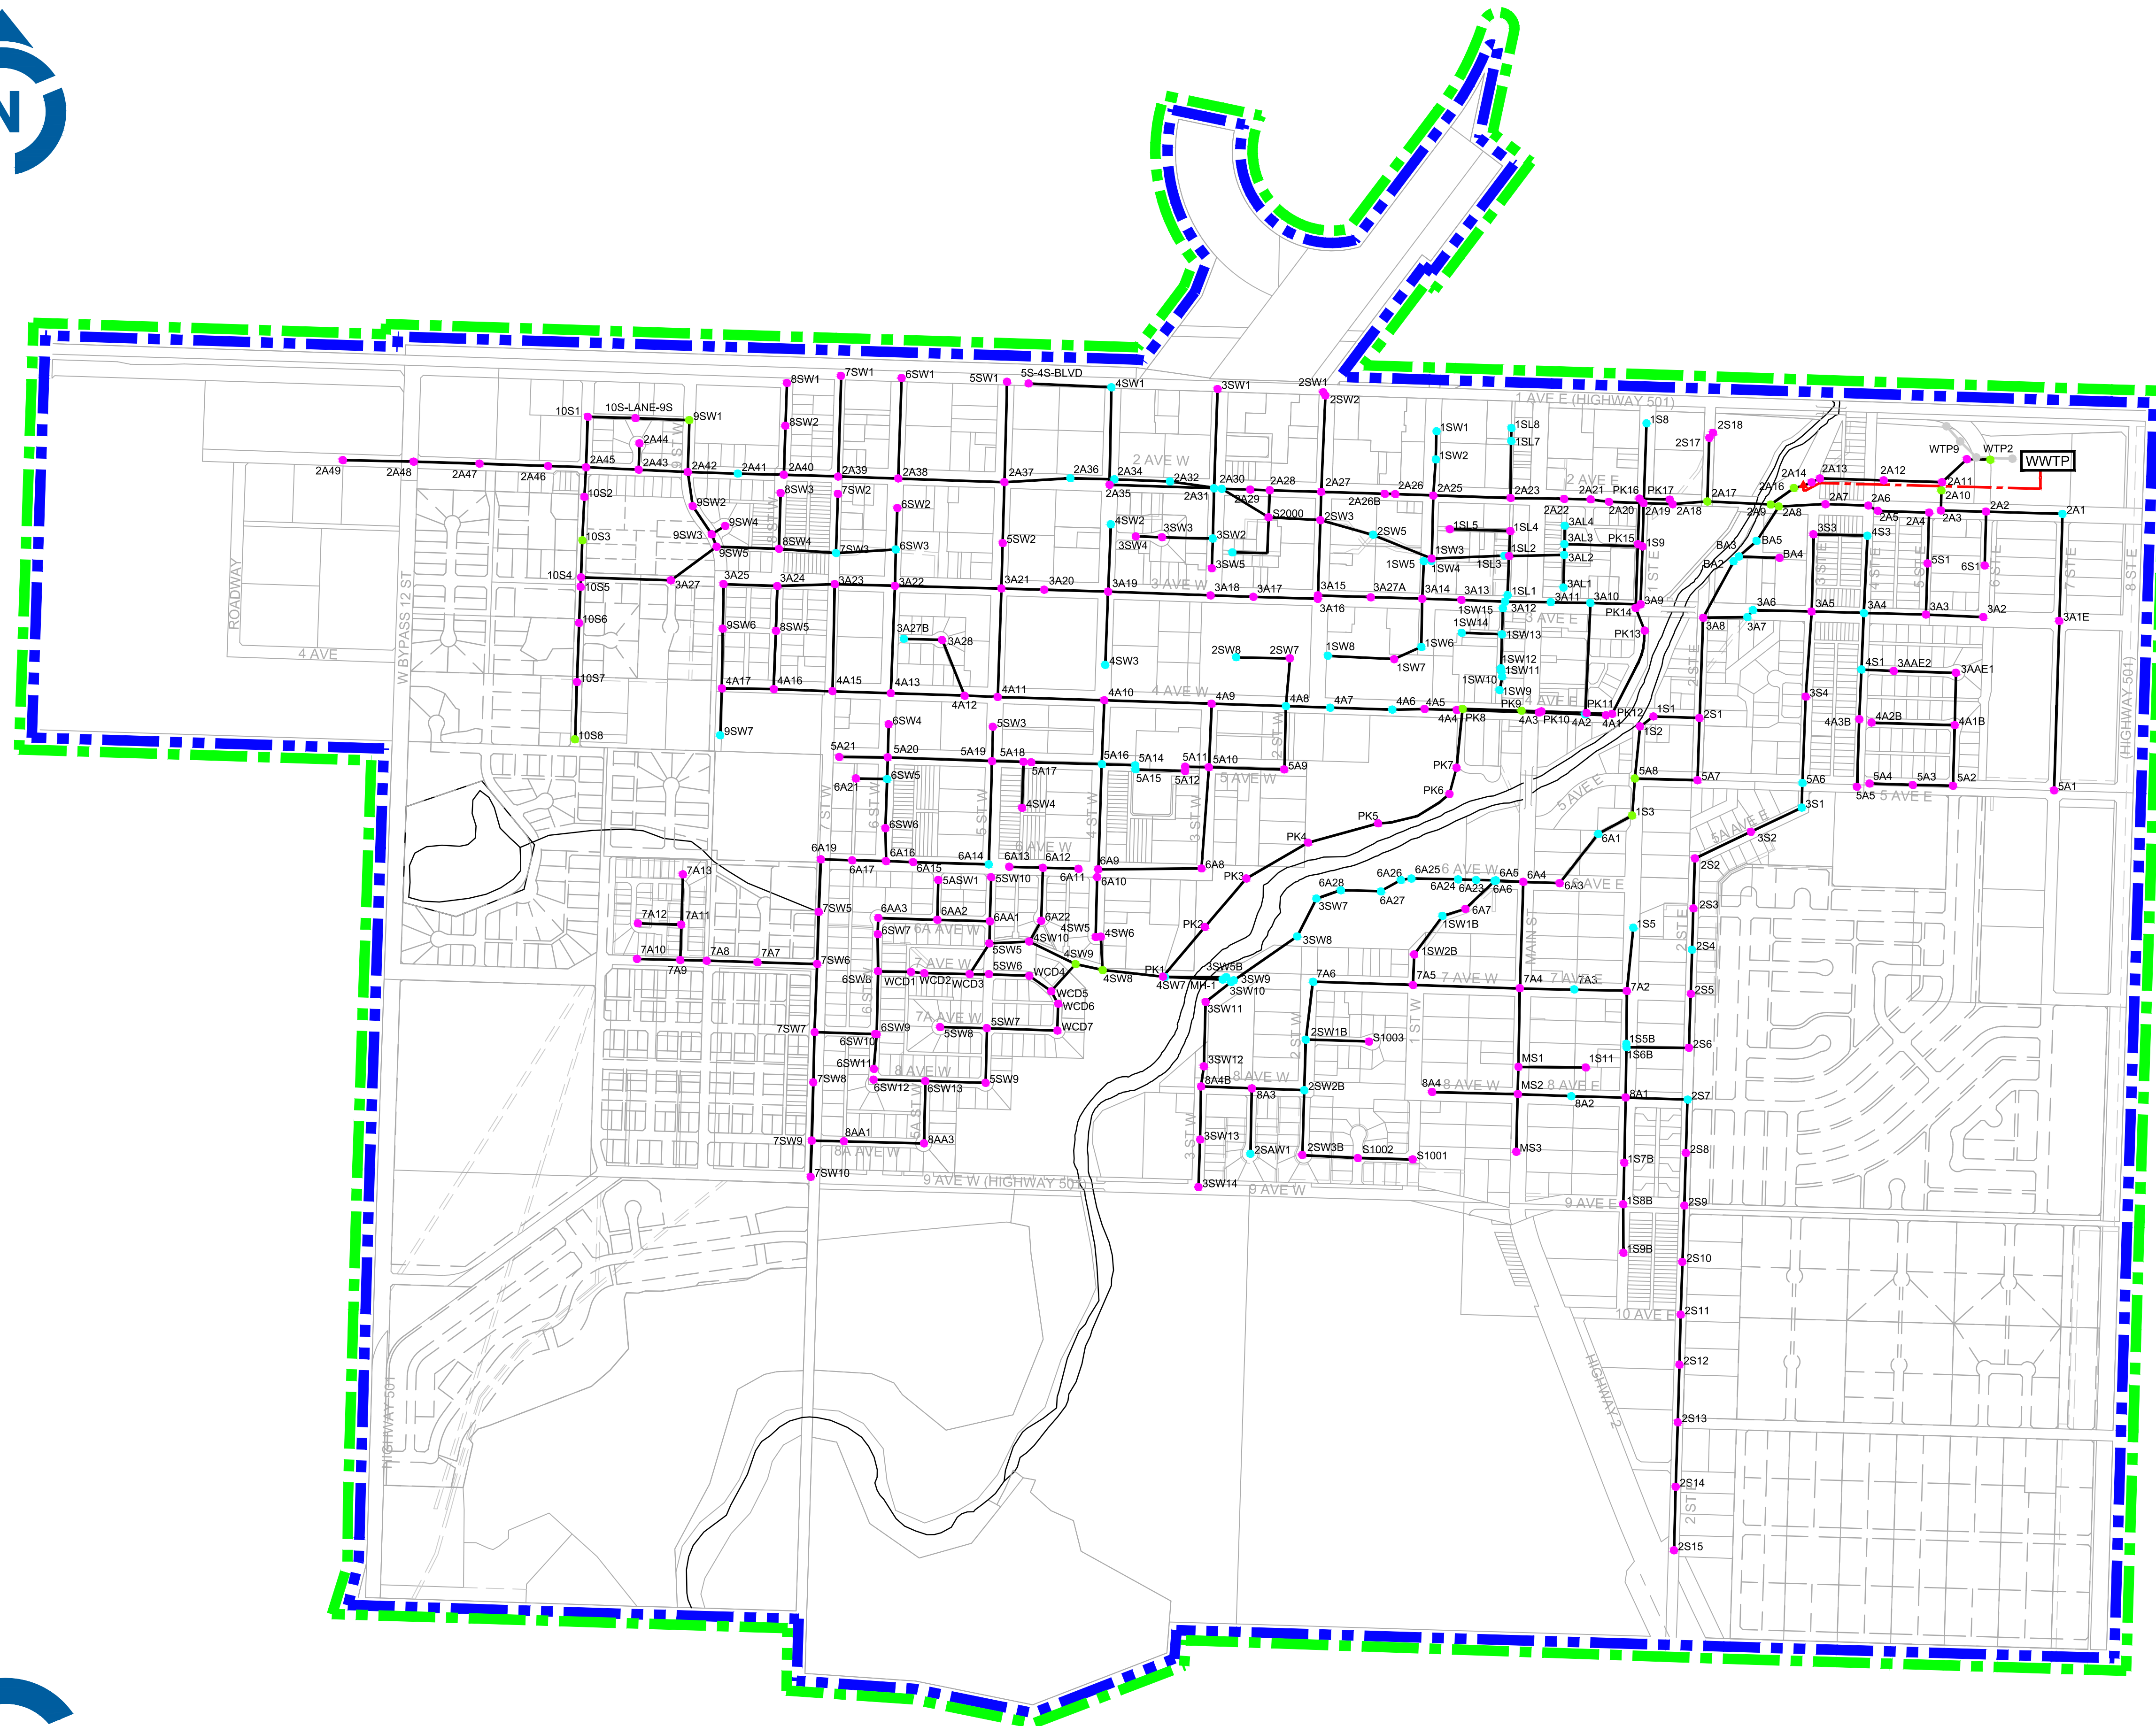
**EXISTING SANITARY SEWER SYSTEM
DRY WEATHER FLOW
FIGURE 4.3**

The modelling results for the existing system under dry weather conditions are shown on **Figure 4.3**. **Figure 4.3** show several manholes in magenta and several are cyan, indicating that the hydraulic grade line is between 1 and 2.5 m and less than 1.0 m from the ground level, respectively. However, some sewer manholes are shallow and the maximum hydraulic grade line is still within the depth of the manhole. The existing system has sufficient capacity to convey dry weather flow.

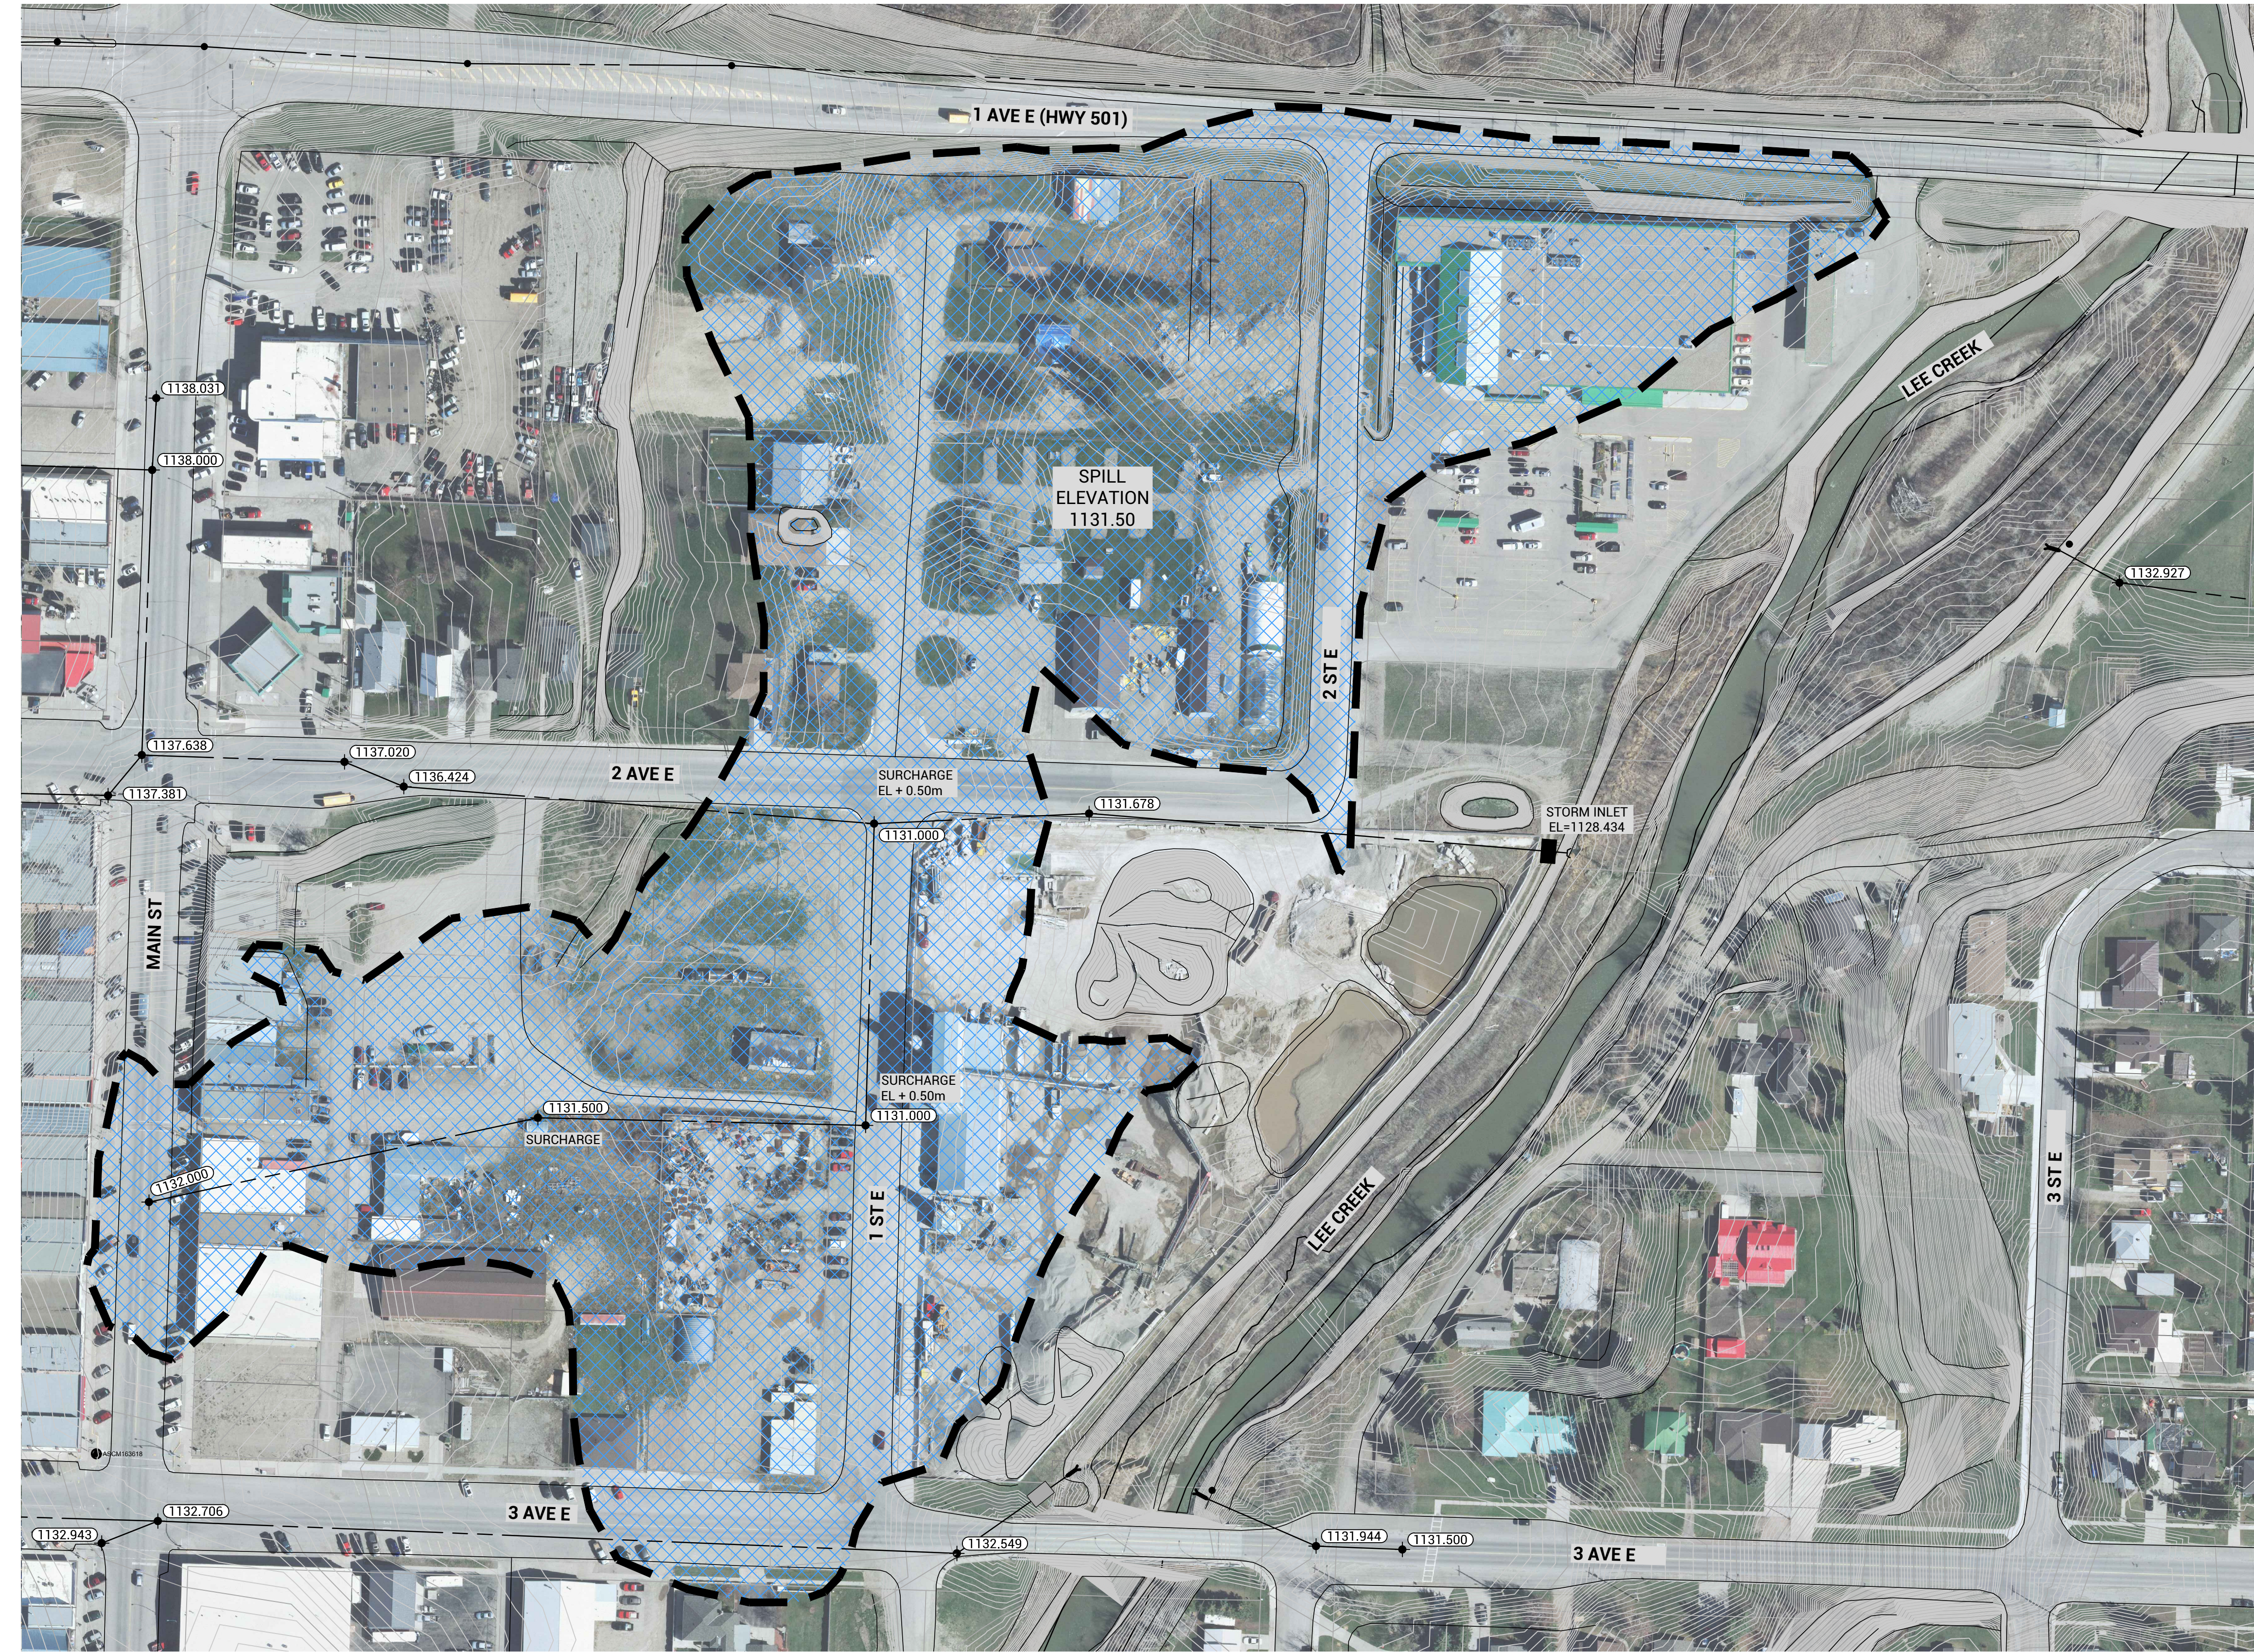
FIGURE 5.3

Main Street downtown floods during heavy Lee Creek flood events. This is due to the fact that the elevation at certain areas downtown is lower than the Lee Creek high water level during a big flood events. The Town currently has one old pump that has reached its service life and operates on a tractor drive shaft that has to be hooked up when the pump is needed to operate. In the absence of this storm pump and the associated control structures that prevents storm water from backing up in the Town's storm pipes and surcharging Downtown, **Figure 5.3** shows the potential extent of flooding that occurs Downtown.

It is highly recommended that the existing storm pump that is used to alleviate flooding the Downtown of Cardston be replaced and a second storm pumping system be installed downstream of the existing along the Lee Creek.

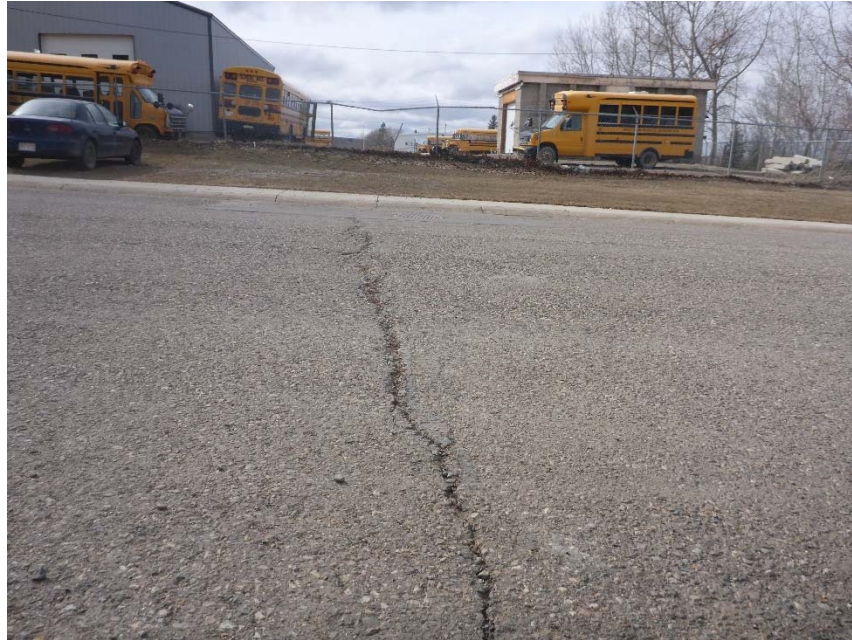
**1 ST E - (3) = Station 0+185
Asphalt - Transverse Cracking**

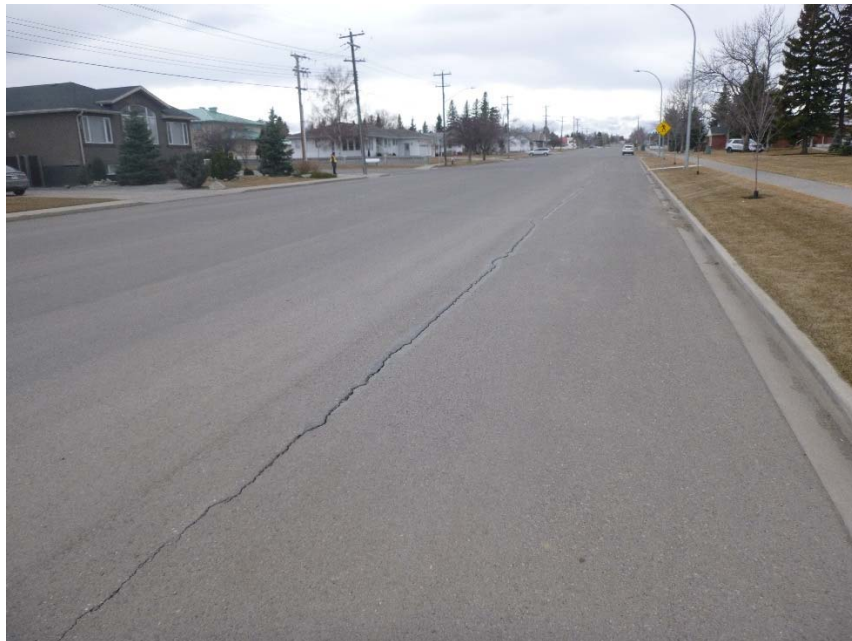
**4 AVE W = Station 0+601 - 0+703
Asphalt - Longitudinal Cracking**

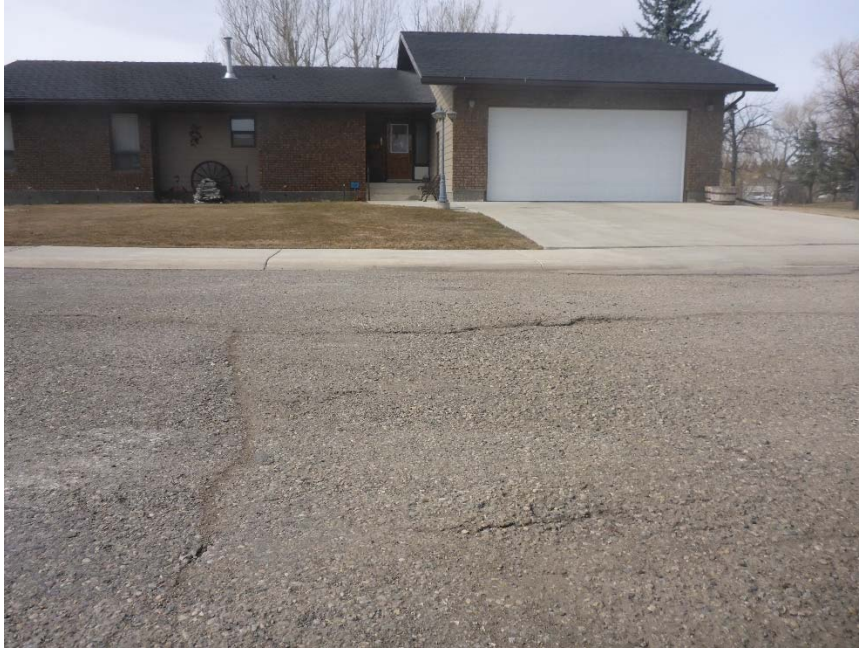
**1 ST E – (2) = Station 0+012
Asphalt - Settlement**

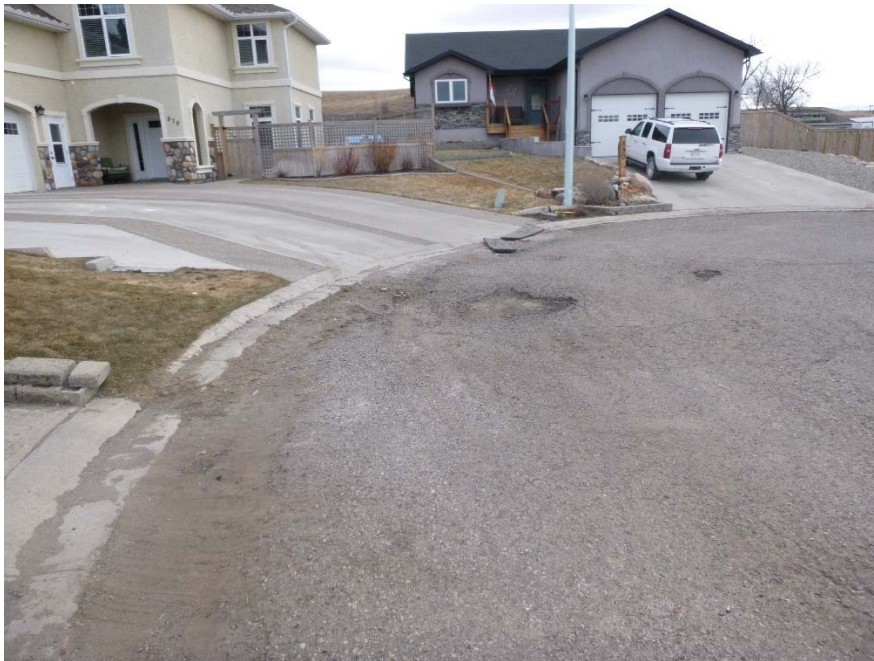
**2 ST W – (3) = Station 1+500
Asphalt - Pothole**

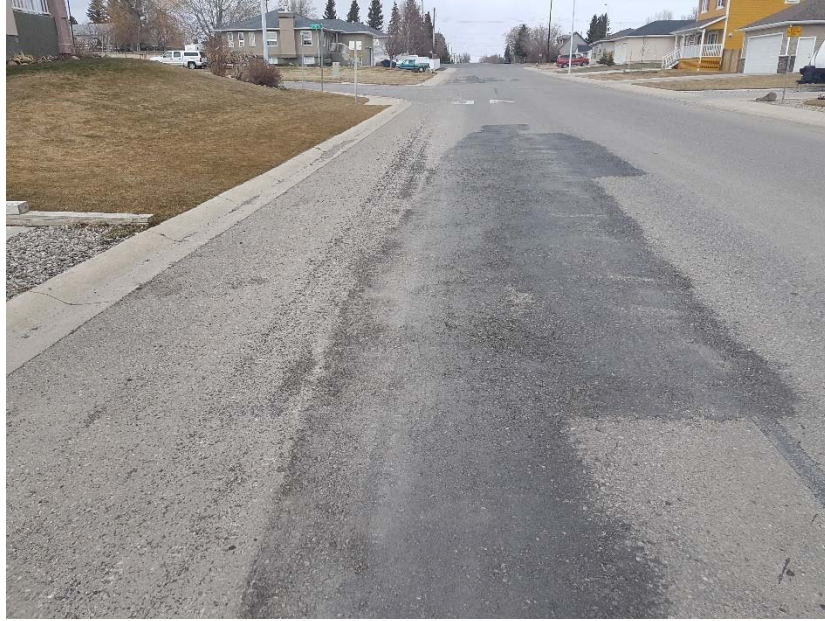
**5 ST W = Station 0+180
Asphalt – Poor Repair**

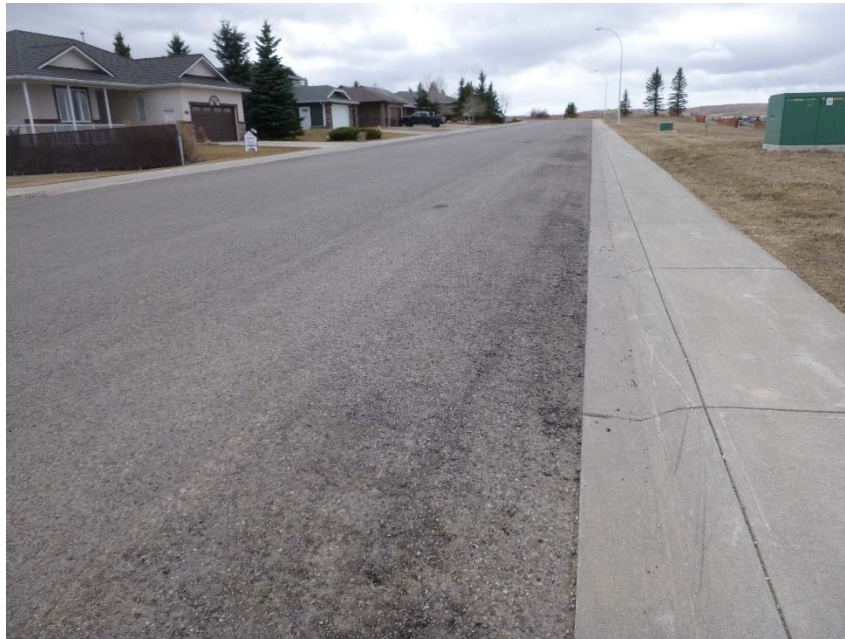
**5A AVE E = Station 0+055 – 0+163
Asphalt – Deterioration**

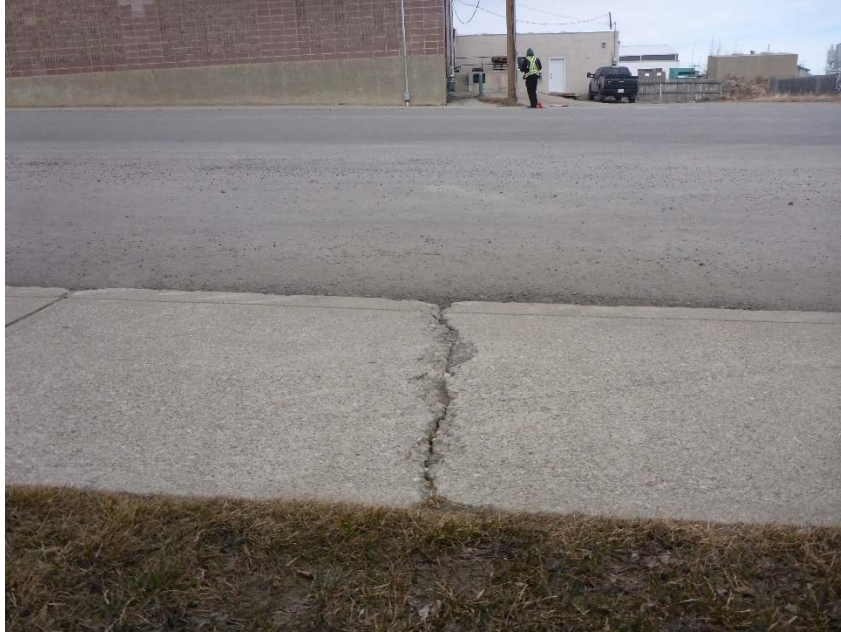
**4 AVE E – (3) = Station 0+027
Concrete – Transverse Cracking**

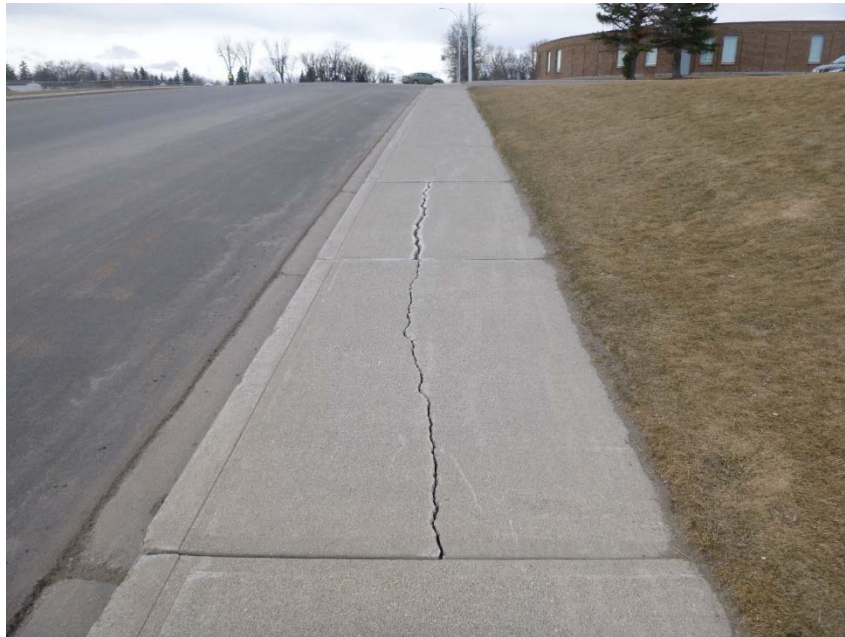
**4 AVE W – Station 0+090 – 0+099
Concrete – Longitudinal Cracking**

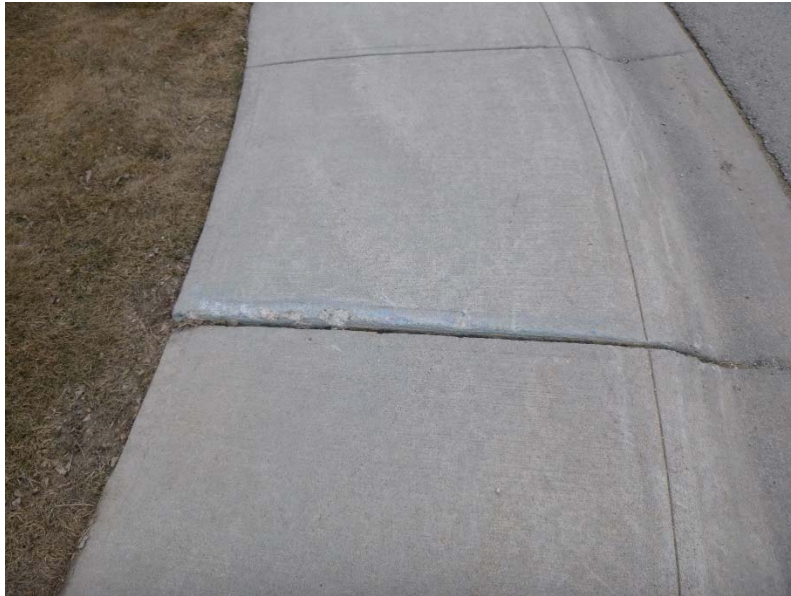
**WEST CREEK DRIVE = Station 0+035
Concrete - Settlement**

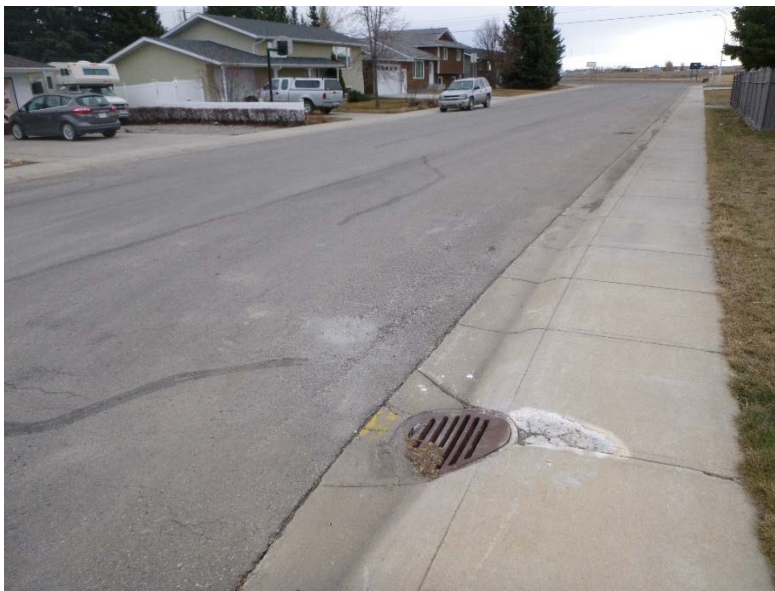
**5 ST E - (2) = Station 0+003
Concrete - Spalling**

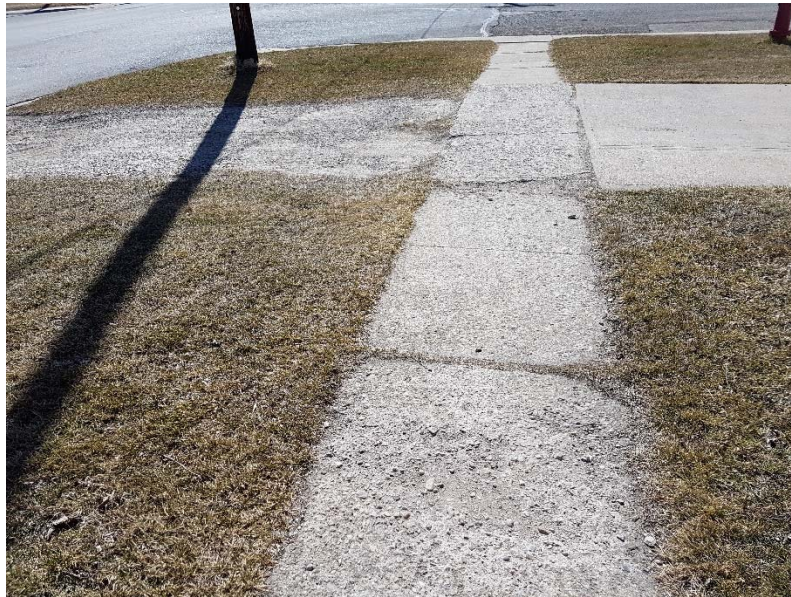
**4 ST W = Station 0+229 -0+279
Concrete – Deterioration**

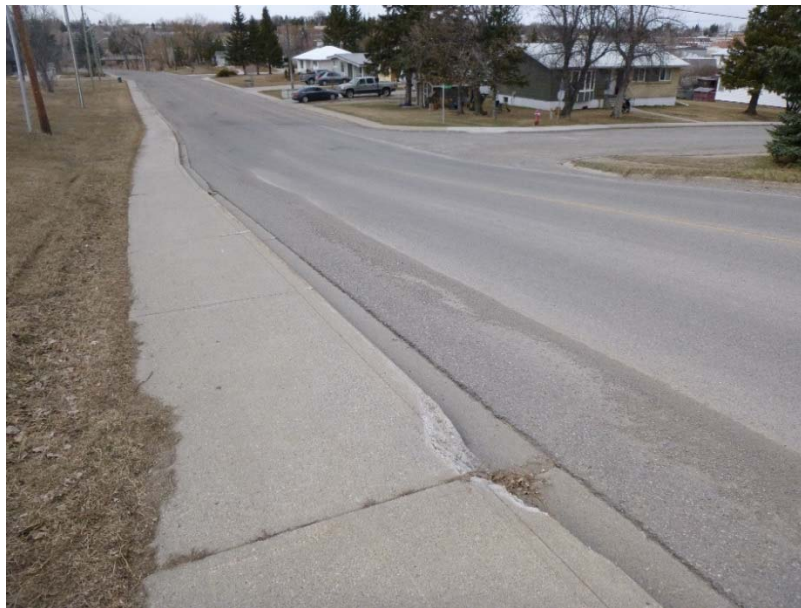
**5 AVE E = Station – 0+771
Curb/Gutter – Deterioration**

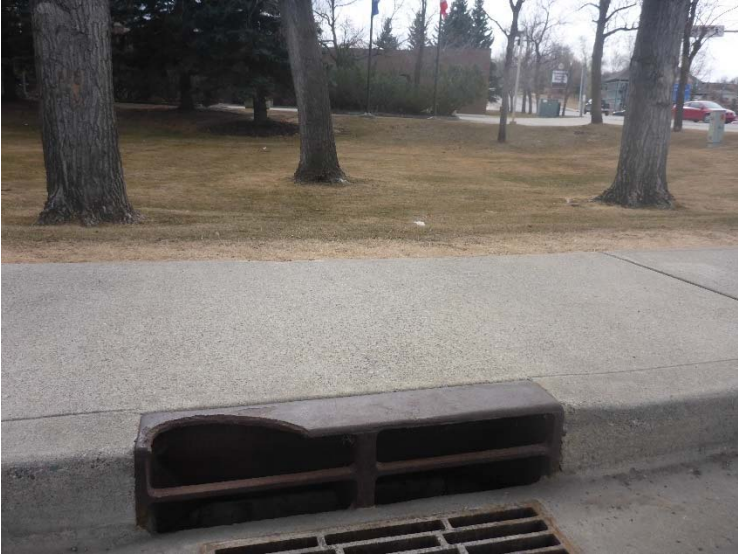
**5 AVE E = Station 0+121
Damaged Catch Basin**

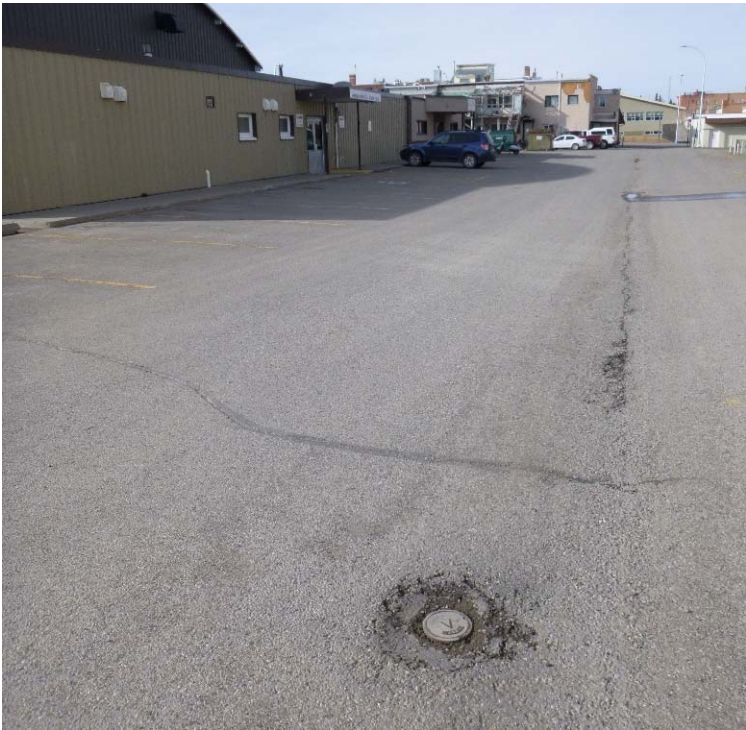
**MAIN A ST W = Station 0+075
Settled Valve**

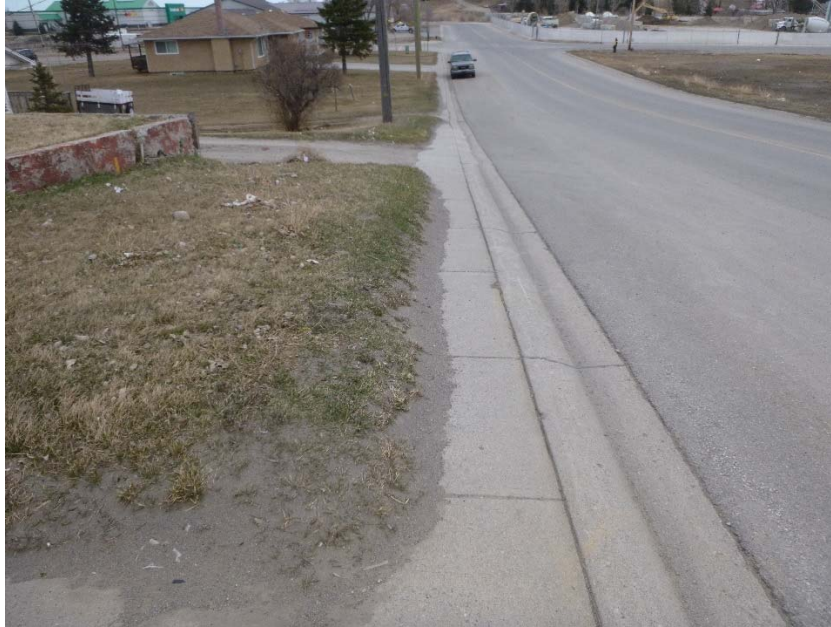
**2 AVE E - (2) = Station 0+081 - 0+181
Ground Encroachment**
