Town of Cardston Infrastructure Master Plan

Report

Update: December, 2017

**RE: TOWN OF CARDSTON
INFRASTRUCTURE MASTER PLAN**

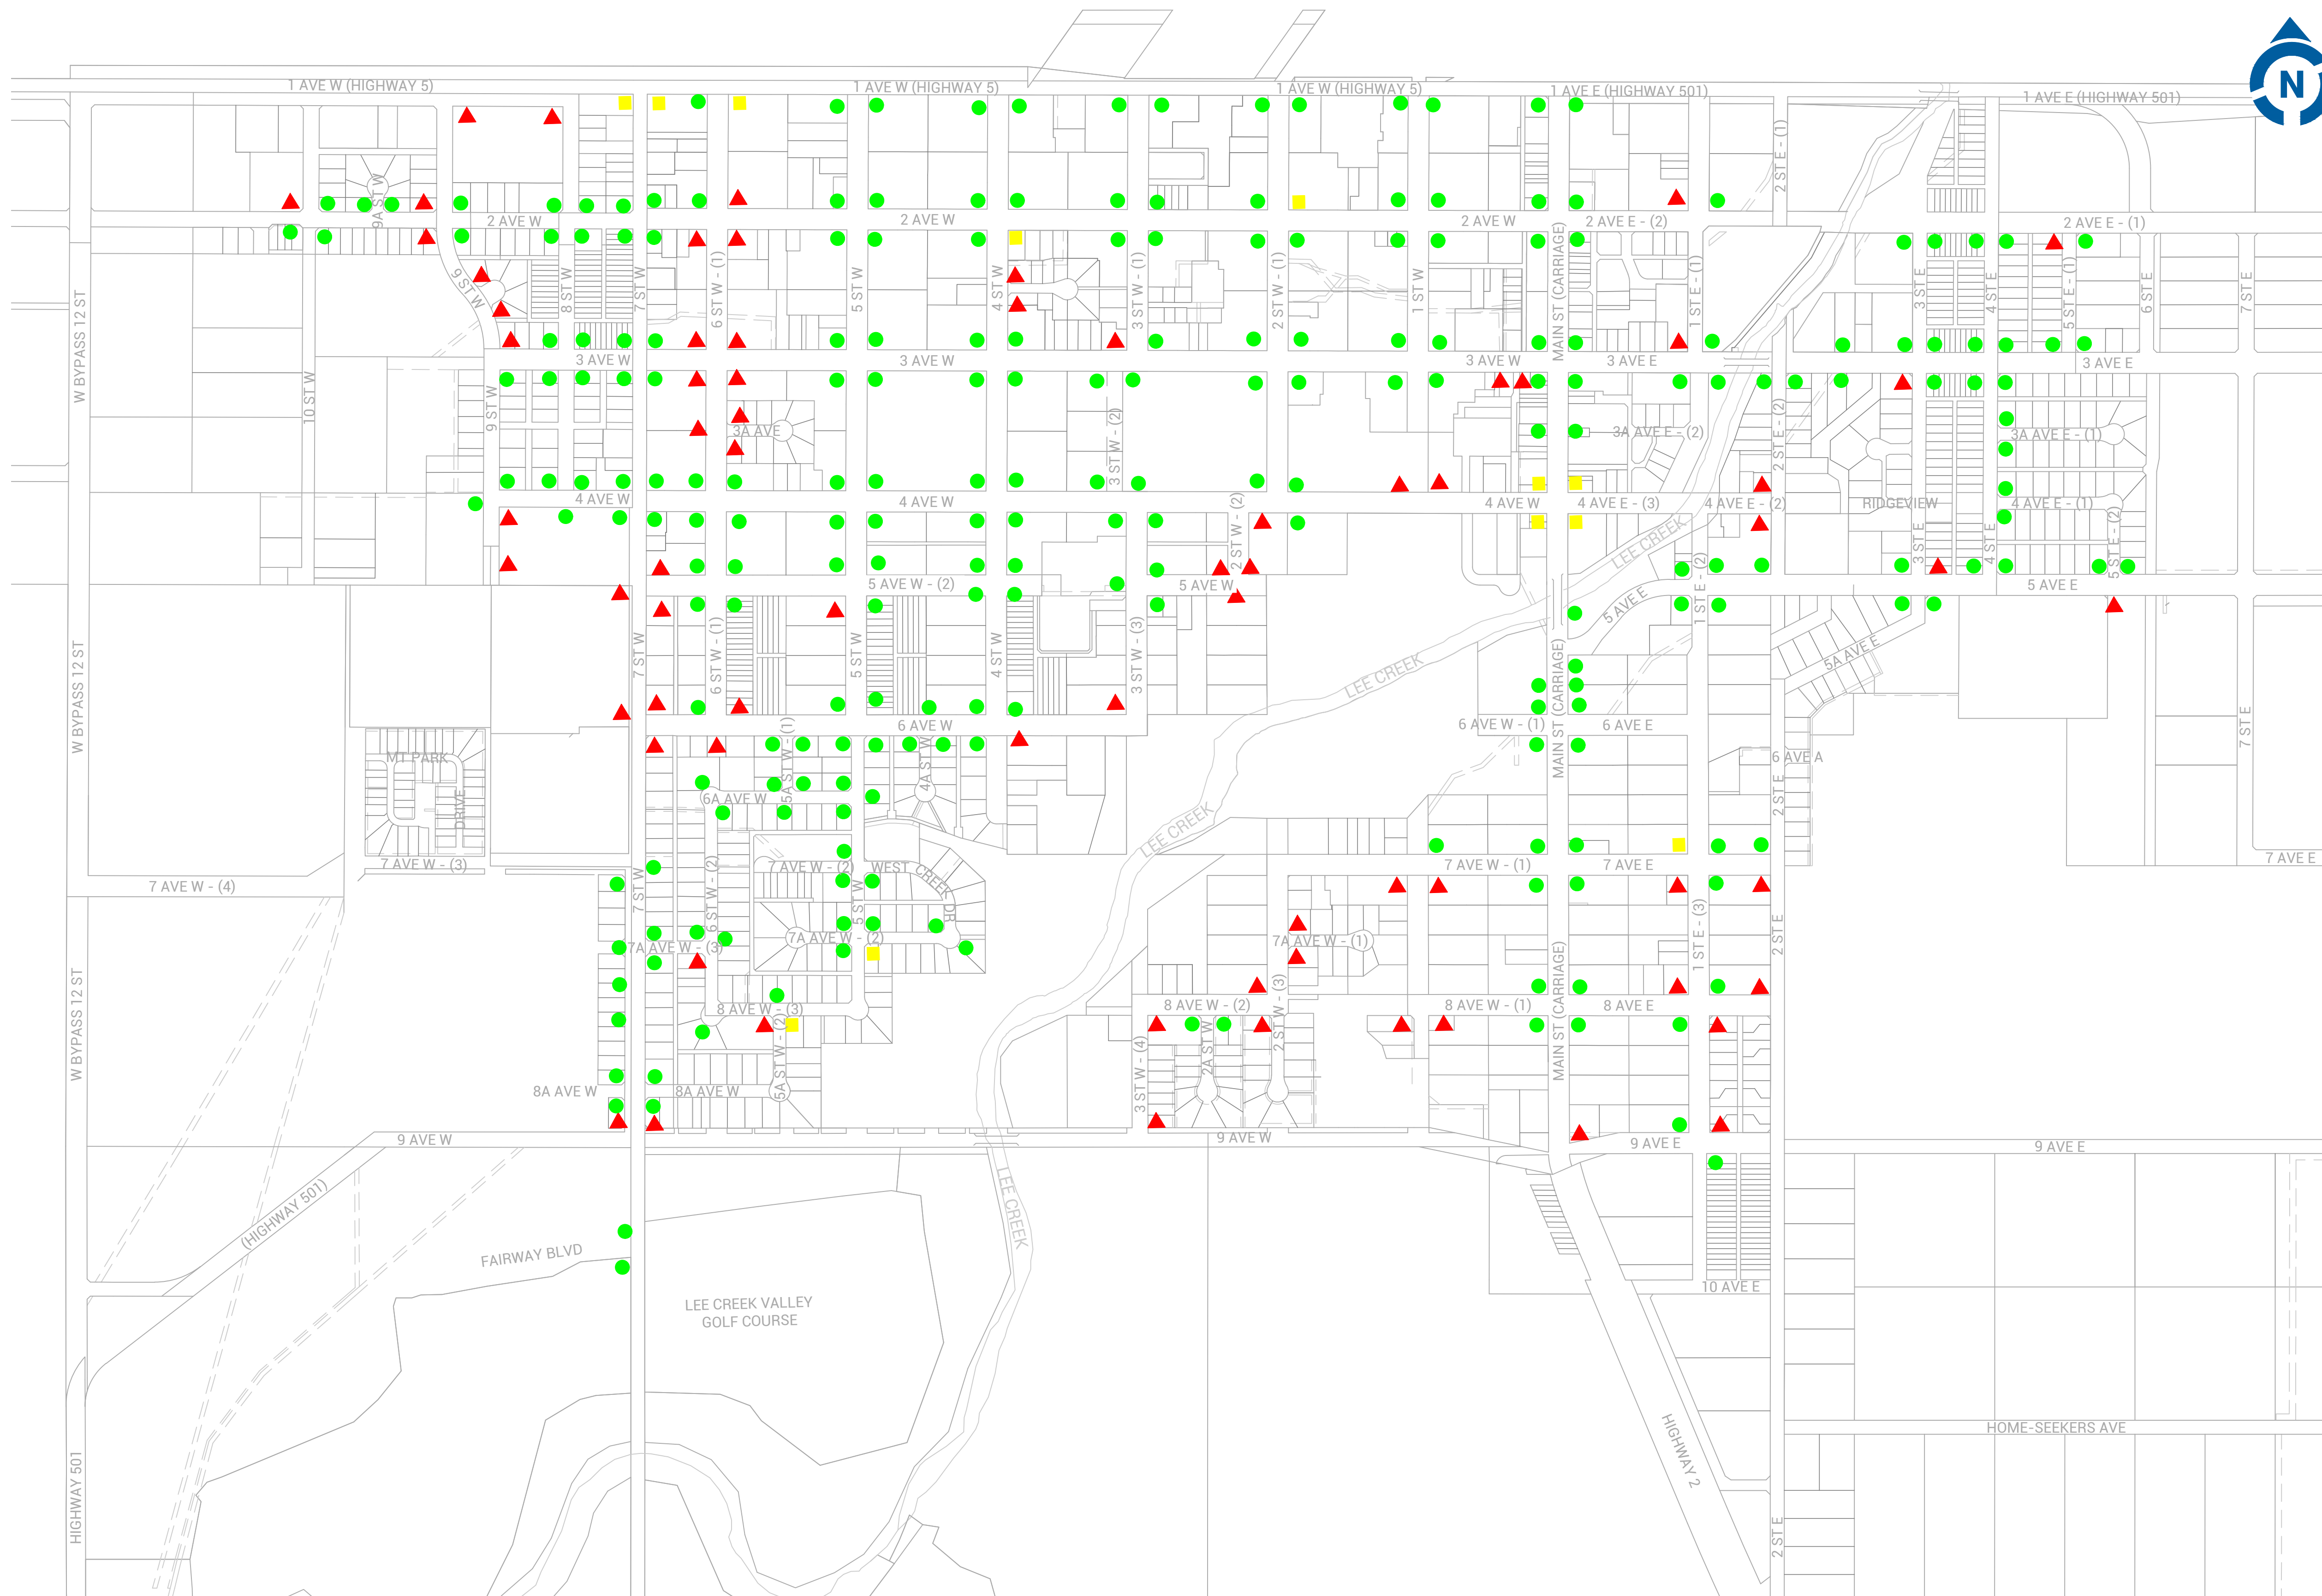
TOWN OF CARDSTON
WHEELCHAIR RAMP LOCATIONS
FIGURE 1.1

- GOOD CONDITION WHEELCHAIR RAMP

- POOR CONDITION WHEELCHAIR RAMP

- NO WHEELCHAIR RAMP
